RE: Category N Baseline Environmental Assessment
Former Power Station and Copper Ore Processing Facility
Lake Linden (Torch Lake Township), Michigan

DISCLOSURE OF A BASELINE ENVIRONMENTAL ASSESSMENT
(FORM EQP4446(REV.3/99))

REGIONAL LOCATION MAP
BASELINE ENVIRONMENTAL ASSESSMENT
FORMER POWER STATION AND
COPPER ORE PROCESSING FACILITIES
TORCH LAKE TOWNSHIP
HOUGHTON COUNTY, MICHIGAN

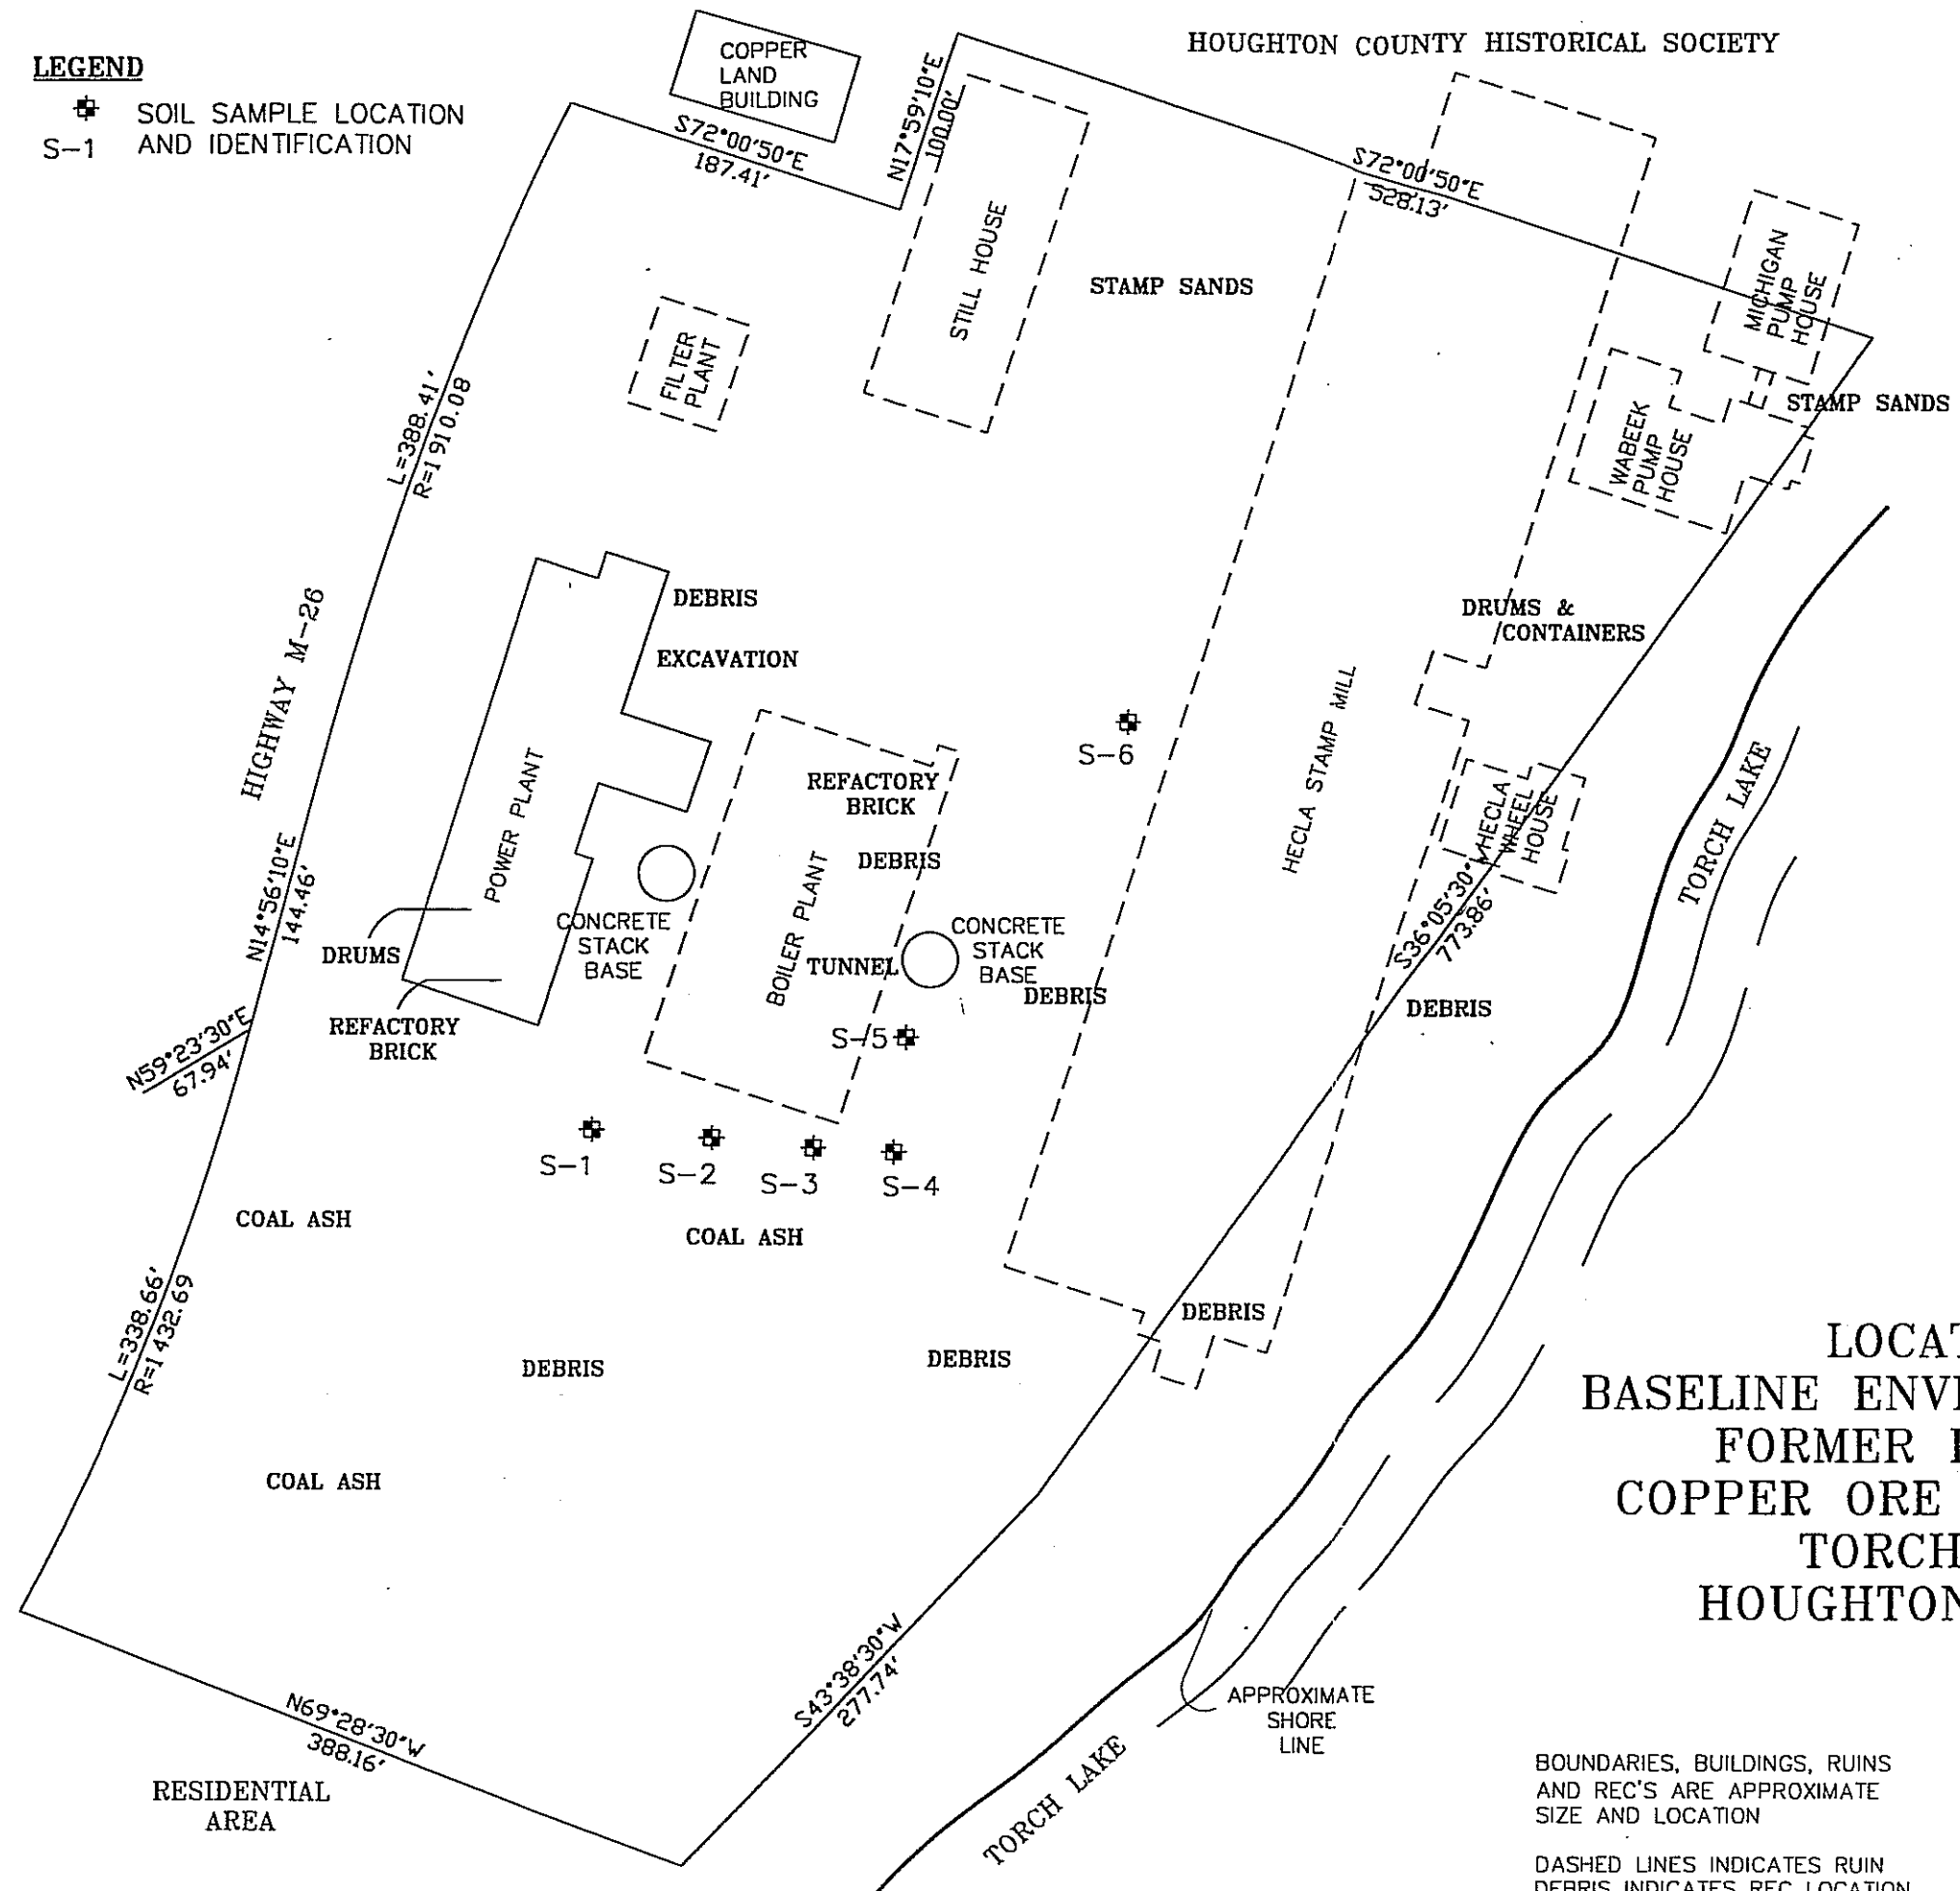
Several abandoned containers have been found on the subject property. The abandoned containers that have been identified consist of steel drums in two general locations on the property. One drum was observed to be floating in the water, which is present within the basement of the former power plant building (see Attachment C, photo #7). Several other drums most of which are crushed and all of which are rusted, were observed among partially buried debris found on the east portion of the site near the shore of Torch Lake (see Attachment C, photo # 11). For personnel safety reasons, the drum located within the basement of the former power plant building can not be accessed. The drums observed among the partially buried debris in the east portion of the site have been determined to be empty. Form EQP 4476, "Notice Regarding Discarded or Abandoned Containers" has been completed for the intact drums observed, and can be found in Attachment E. The locations of the discarded and abandoned drums are displayed on Figure 5, which can be found in Attachment A.

LOCATION OF IMPACT
BASELINE ENVIRONMENTAL ASSESSMENT
FORMER POWER STATION AND
COPPER ORE PROCESSING FACILITIES
TORCH LAKE TOWNSHIP
HOUGHTON COUNTY, MICHIGAN
FIGURE 5

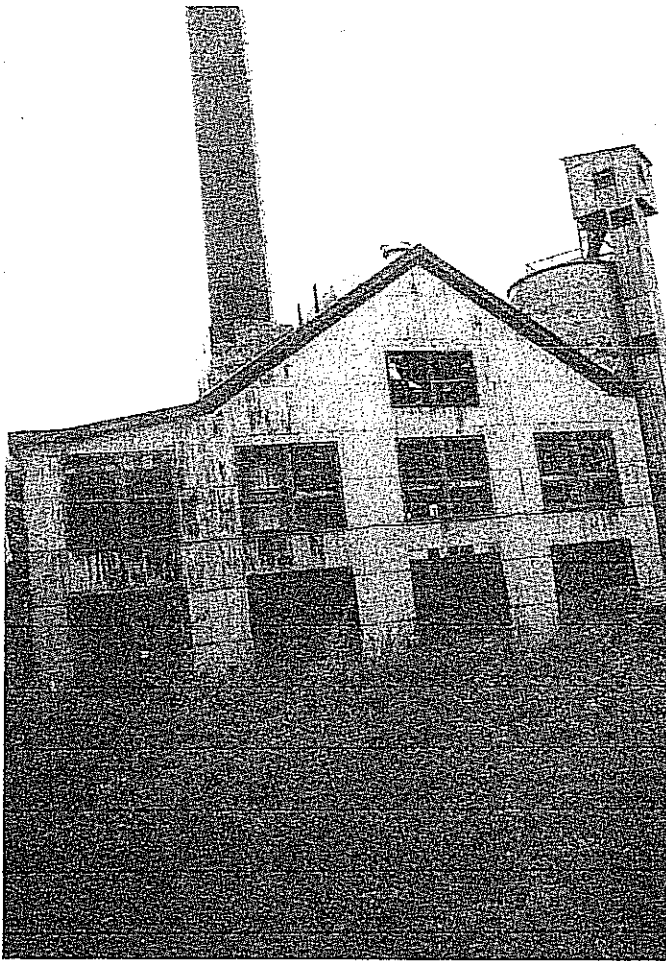
Condemned Building - The building which remains on the site bears a notice on one its doors identifying the structure as Condemned as Dangerous and Unsafe. The building should be properly razed and the material disposed of in an acceptable manner.

SOUTH SIDE OF POWER PLANT BUILDING

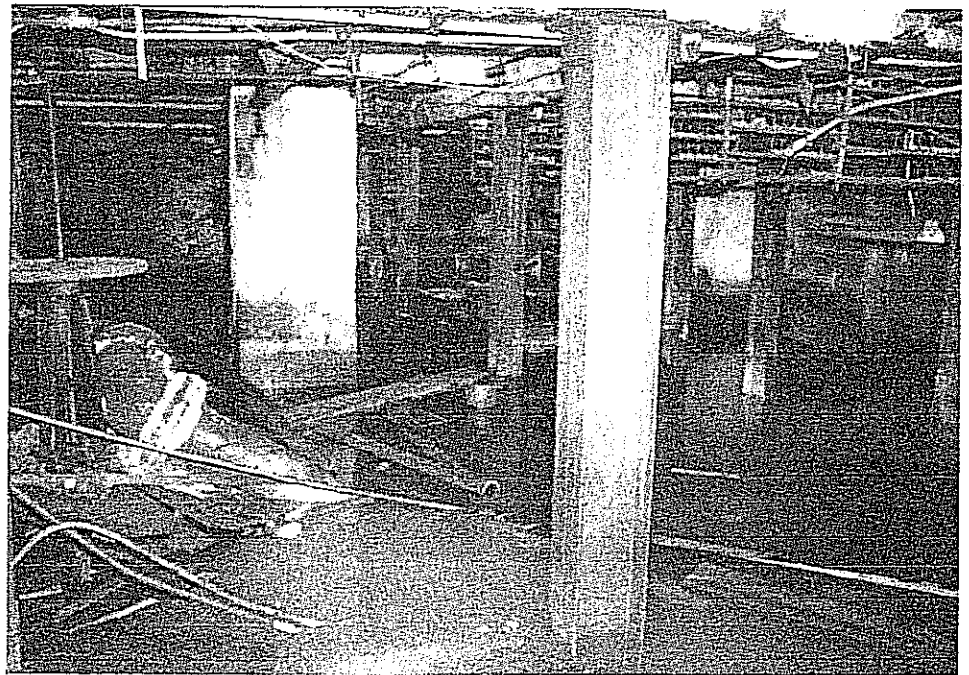
- Water in basement of the building - There is a large volume of water in the lower level of the power plant building. This water may contain elevated concentrations of metals or other compounds used in the building. The presence of the water may obscure, by submergence, evidence of the presence of hazardous materials.

- Water in basement of the building - There is a large volume of water in the lower level of the building. This water may contain high concentrations of metals or other compounds used in the building. This material may pose a threat of a release of a hazardous substance. The water, which has accumulated within the basement, should be sampled for appropriate parameters. (This should be considered a REC until investigative efforts indicate there is no threat to the environment.)
At a minimum, this water should be characterized and disposed of properly.

FLOODED LOWER LEVEL OF POWER PLANT BUILDING

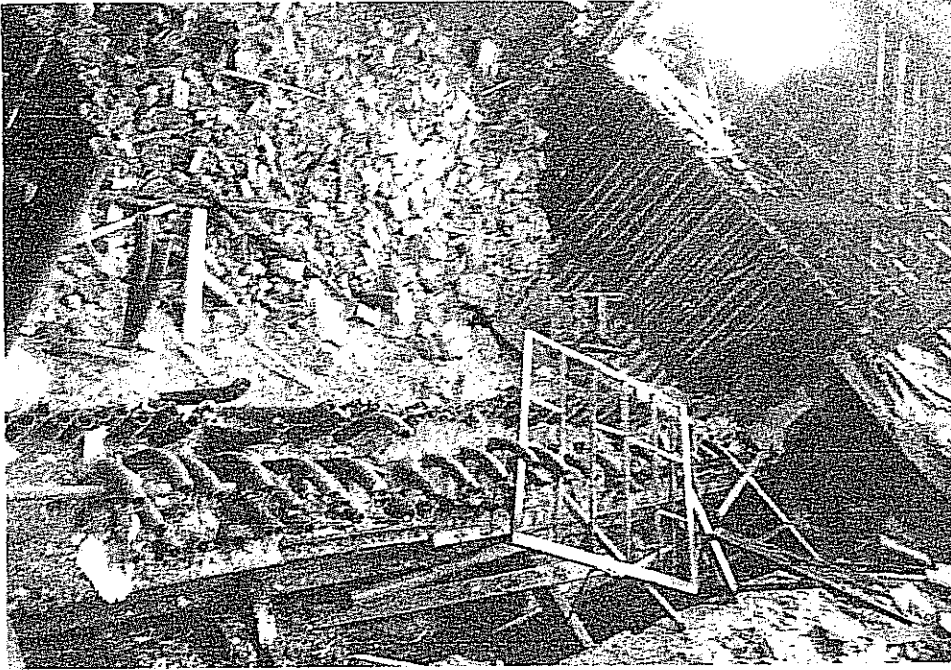
DISMANTLED BOILER IN POWER PLANT BUILDING

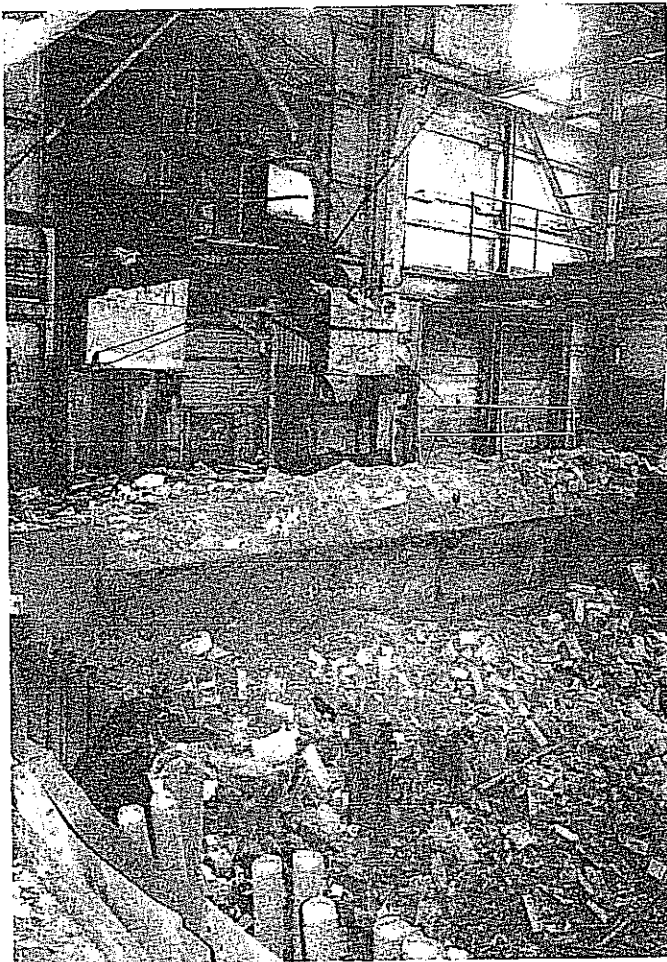
**DISMANTLED BOILER AND
COAL SHOOTS IN POWER PLANT**

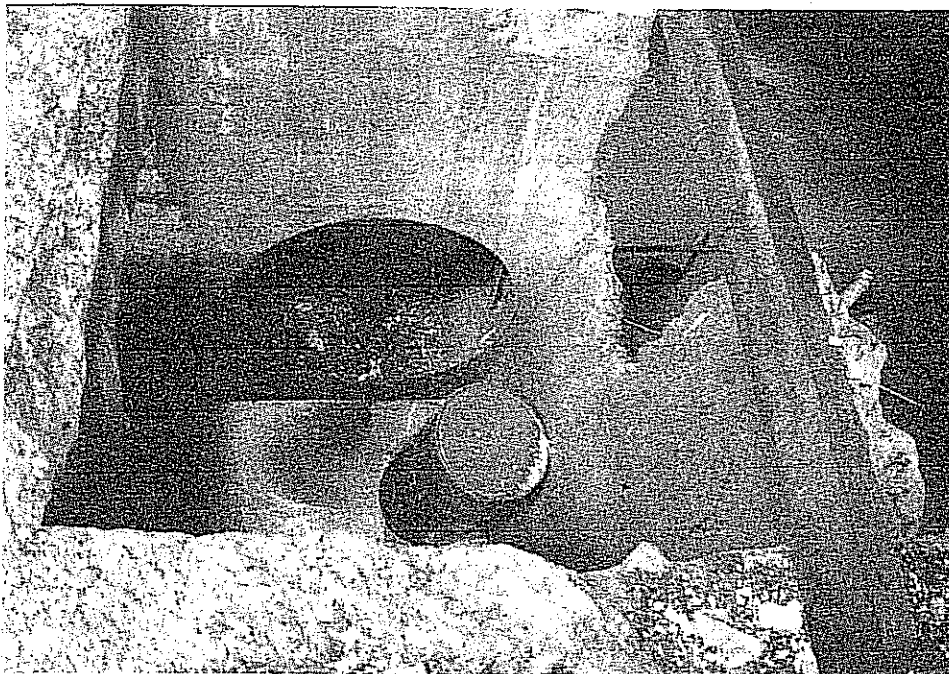
- Drums inside of building - The contents of the drum observed inside the power plant building at the site are unknown. The drum is presumed to represent a material threat of a release of a hazardous substance.

- Drums in and outside of building - The contents of the drums observed at the site are unknown, the drums are presumed to represent a material threat of a release of a hazardous substance. The contents of the drums should be identified and then disposed of properly.

**DRUMS IN FLOODED LOWER LEVEL
OF POWER PLANT BUILDING**

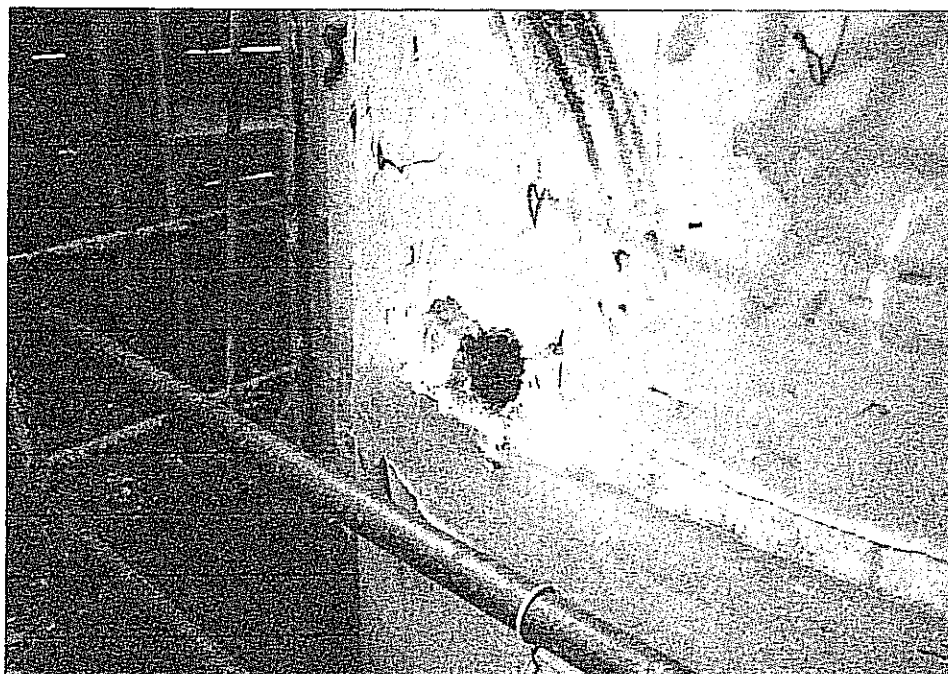
**POSSIBLE ASBESTOS CONTAINING INSULATION AROUND
SMOKE STACK SOUTH END OF POWER PLANT BUILDING**

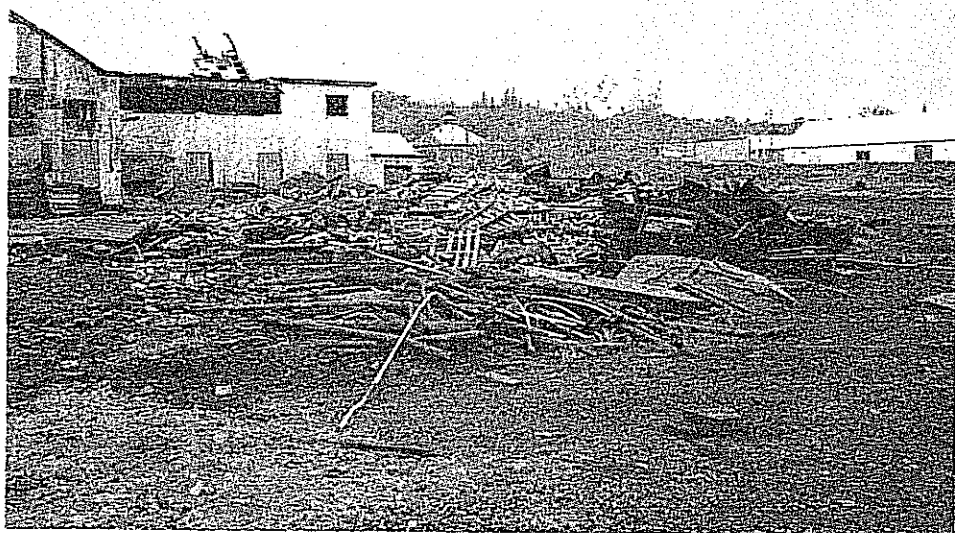
- Improper disposal of general wastes over the years - The disposal practices of waste at the facility is not completely known. There are several areas on the property, which are covered with debris (including coal ash and stamp sands) exceeding 10 feet in depth. It is not known what materials may have been included with the debris.

- Improper disposal of general wastes - The disposal practices of waste at the facility is not completely known. There are several areas on the property which have several feet of debris (including coal ash and stamp sands) exceeding 10 feet in depth, piled in haphazard manner. It is not known what materials may have been included with the debris. This should be considered a REC until investigative efforts indicate there is no threat to the environment. Further research on waste disposal practices and a subsurface investigation of these areas may be appropriate.

**DEBRIS PILE ON BOILER PLANT RUINS BOILER
PLANT BUILDING IN BACKGROUND - LEFT**

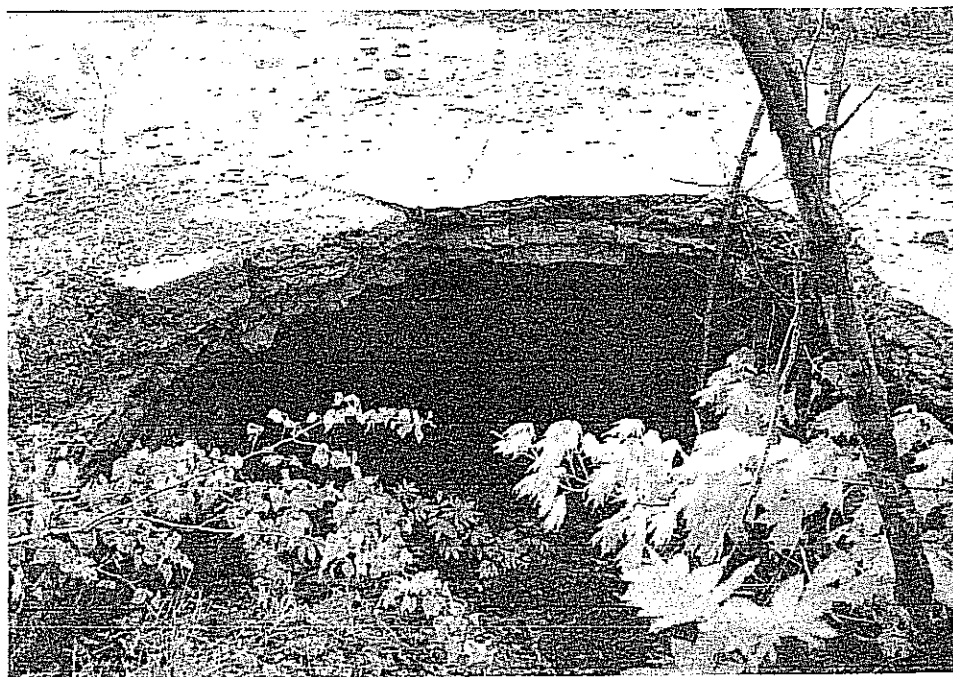
- Tunnel-Portions of a brick lined tunnel were found adjacent to the foundation of the former boiler house. Because of concerns regarding personnel safety, the interior of the tunnel could not be inspected. There may be hazardous materials in the inaccessible portions of the tunnel.

TUNNEL ENTRANCE UNDER BOILER PLANT RUINS

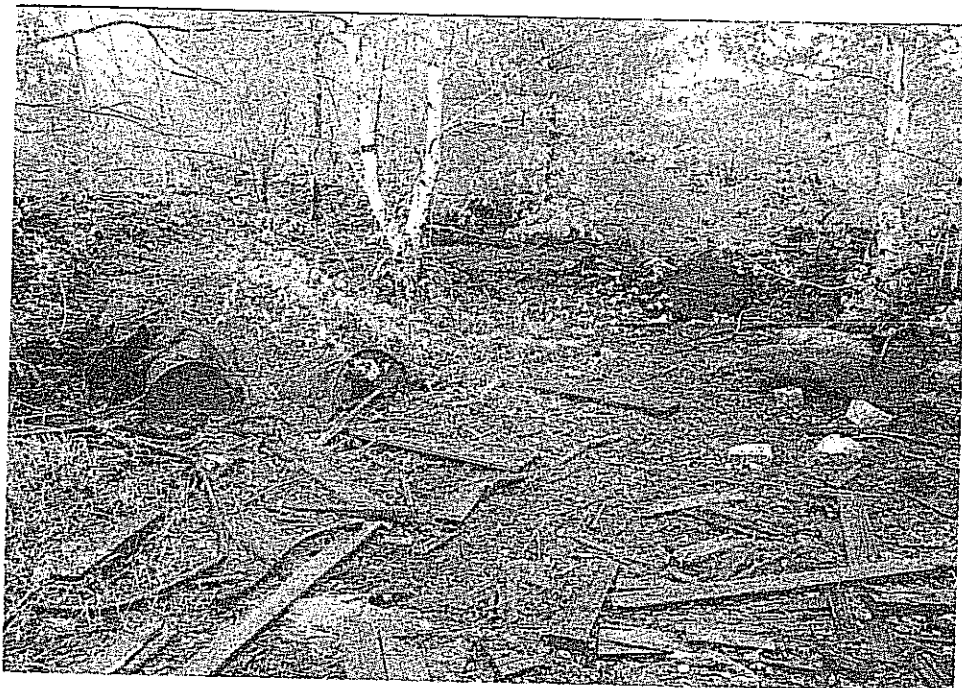
**PARTIALLY BURIED DRUMS AND OTHER DEBRIS
- EAST CENTRAL PORTION OF THE PROPERTY**

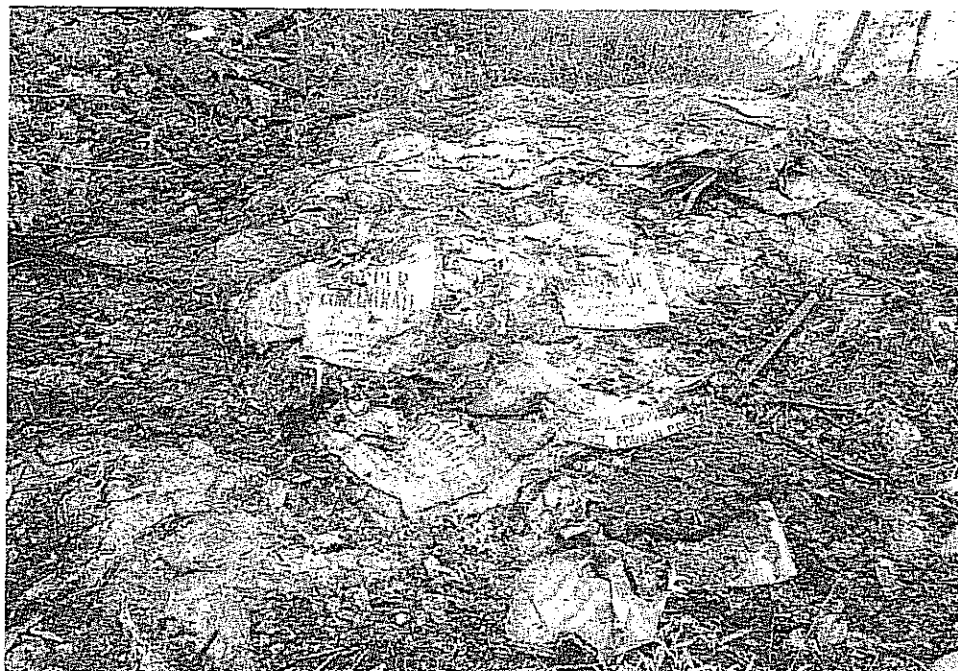
- Copper Concentrate Bags - The pile of copper concentrate that appeared to have residue in them should be considered a REC as they may be releasing hazardous material into the environment.

**PILE OF COPPER CONCENTRATE BAGS AND OTHER
DEBRIS - EAST CENTRAL PORTION OF THE PROPERTY**
